BUST THAT RUST

Restored to factory solidity (sort of), JJ's 535i gets the Rustbuster treatment to keep it that way for good

BMW 535i V8 (E39)

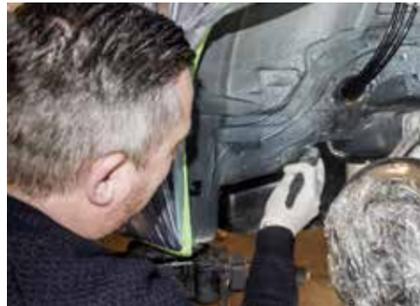
▲ Chris at Rustbuster probe's the deepest cavities.

The penetrator, which is a very low viscosity oil, was injected into hard-to-reach areas with a probe (steady...) to coat the insides of the sills, behind panels and into subframes. In order to get into these chassis voids, two additional holes had to be drilled. These would be de-burred and thoroughly rust proofed at the end of the process.

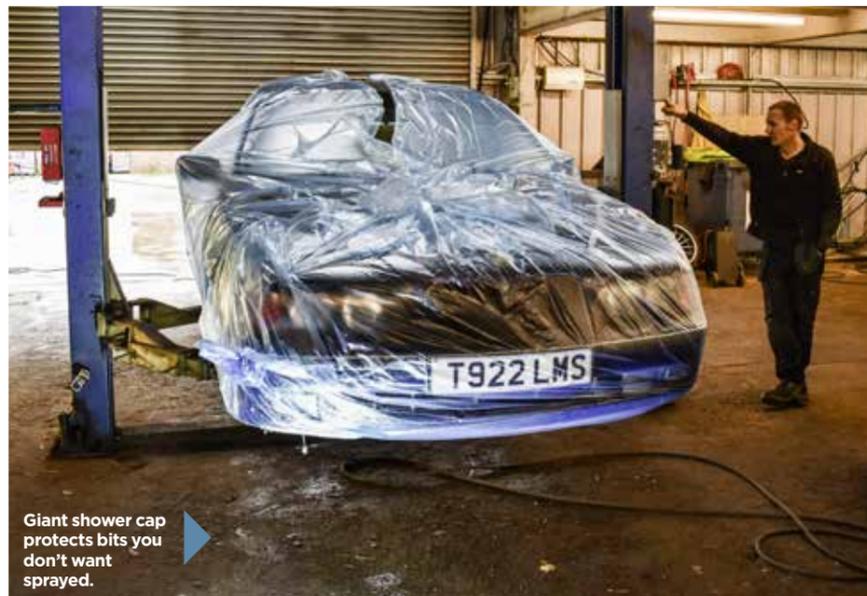
▶ Giant shower cap protects bits you don't want sprayed.

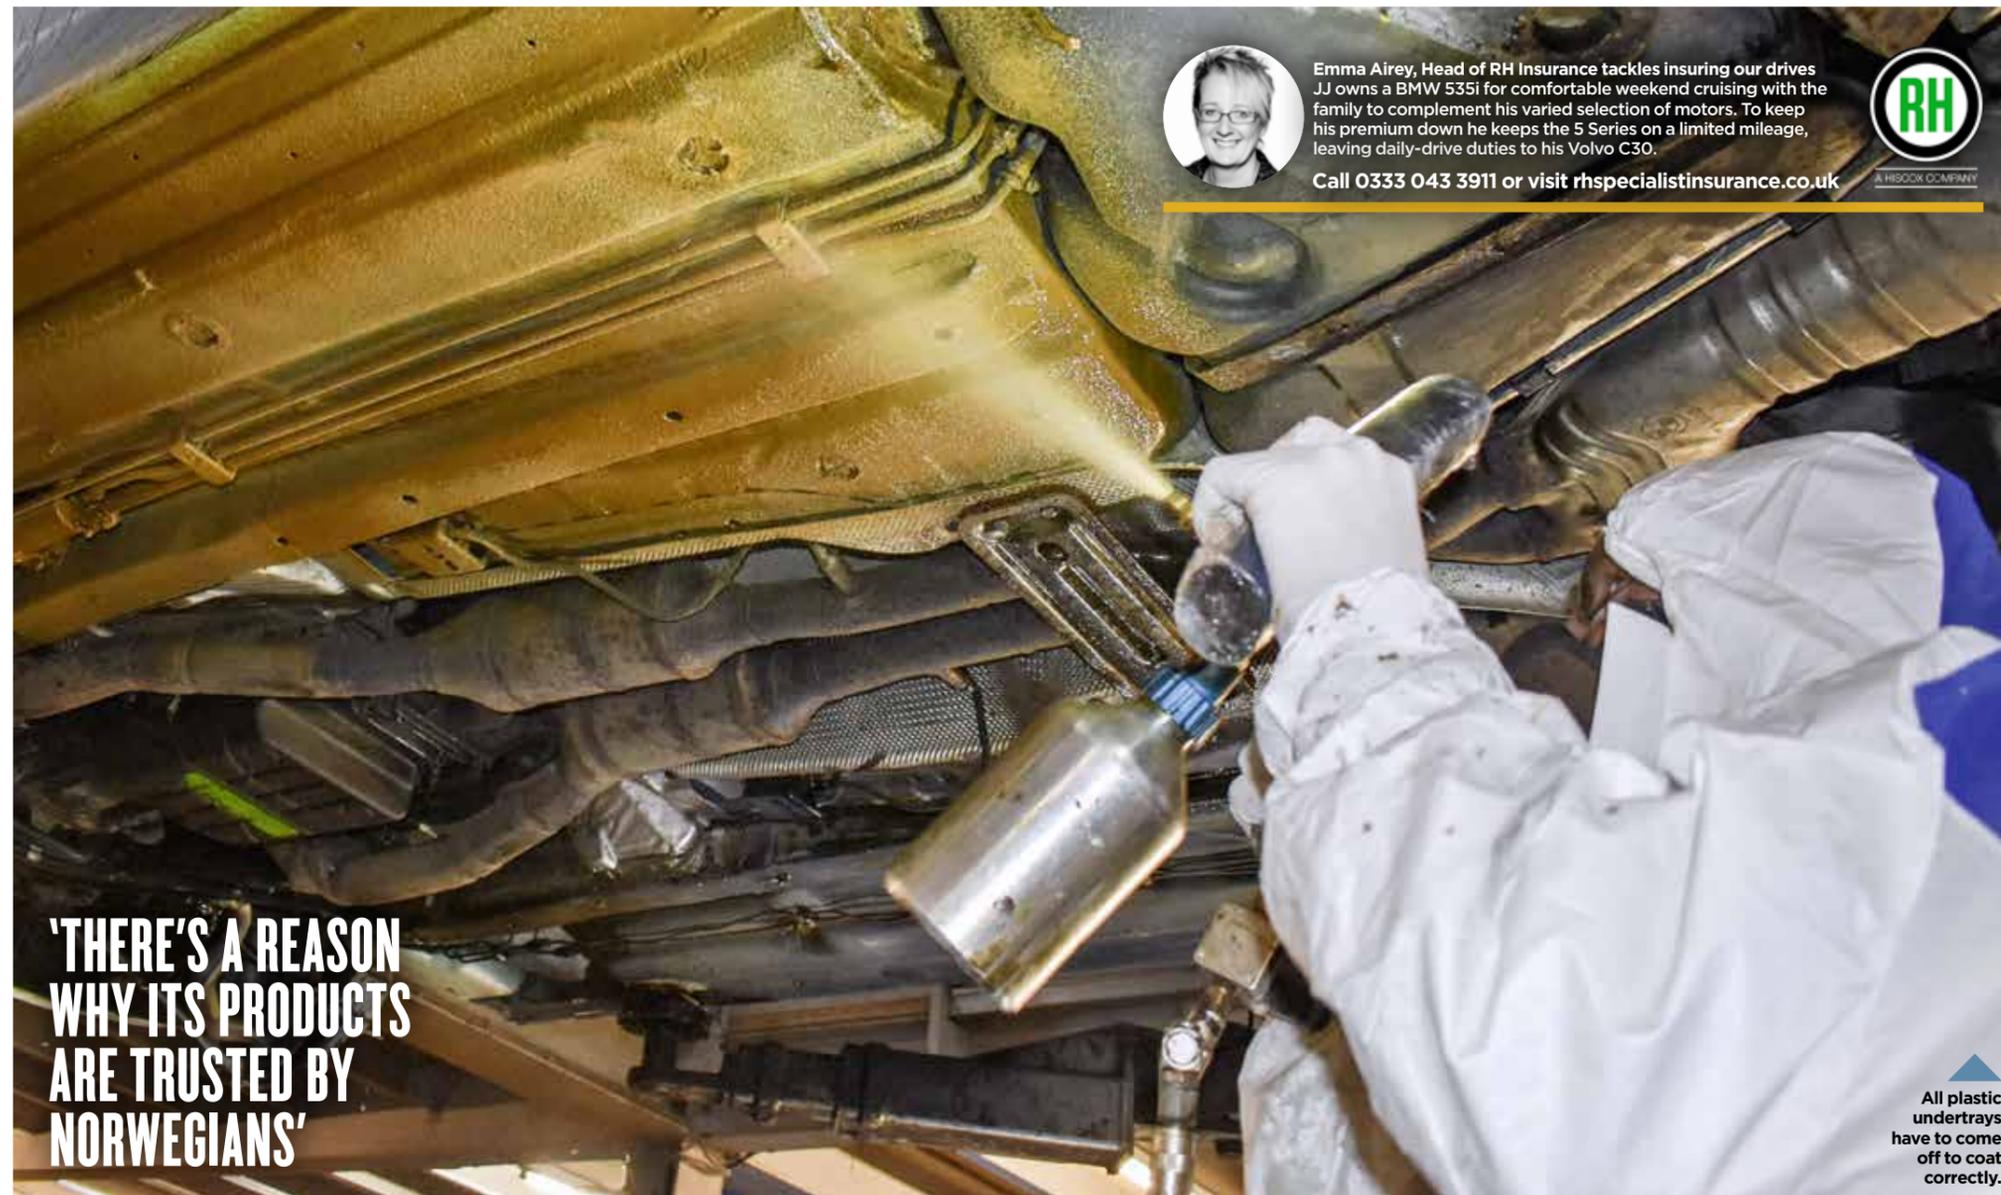
▲ All plastic undertrays have to come off to coat correctly.

oil. The first step involved someone crawling under the 5 Series to do battle with the plastic liners and their (as it turned out) heavily corroded fasteners. Unsurprisingly for a car of this age and value, previous owners had tried to maintain it, with varying levels of success. The result was some linings that were barely hanging on by one or two clips, and others that were stuck in place.

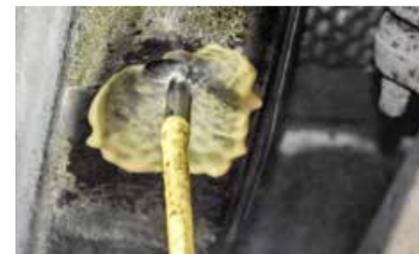
▲ Insert the probe and squirt, this won't hurt...

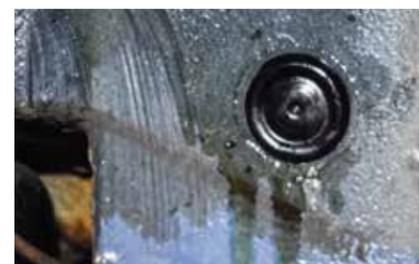
▲ Excess oil is wiped off any parts that get hot.

Once the process was done, all excess oil was wiped off any components such as the manifold or exhaust. With the undertrays refitted, that was it: the Five and I are once again ready to hit the UK's wintery roads. JJ
