1960 Morris Minor Convertible Engine 998cc/4-cyl/OHV Power TBC **Torque** Hopefully sufficient Gearbox 4-speed manual 0-60 Mavbe Top speed Hopefully raised Fuel economy Who knows?

Work done Rust stopped once and for all with a trip to Rustbuster.

Rust-free Matt future-proofs his convertible Minor project

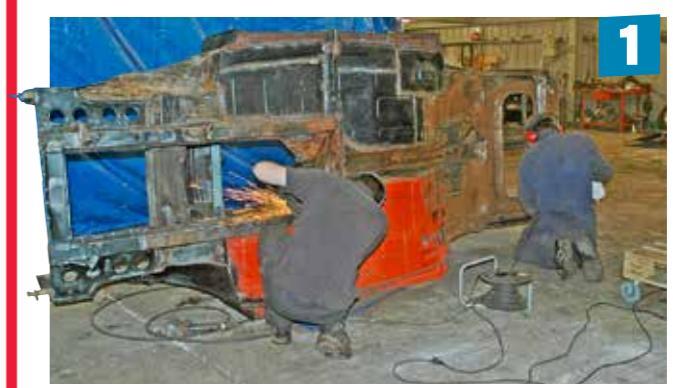
BEFORE

Rust removed and converted,

all ready for treatment

The guys set to work first removing any trace of old surface rust and old coatings by means of rotary wire brushes and MBX stripper tools. They then ground back any undressed welds with flapwheels. Next, the surface was degreased before application of FE123 rust converter to treat any pitted surfaces or seams

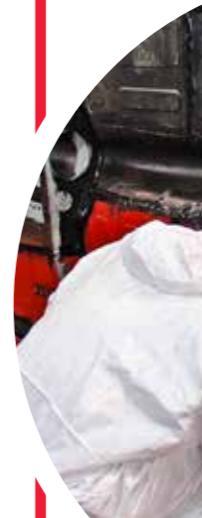
Stripe coat

Edges and seams were stripe-coated for coverage where it mat tered mos and where spraying may not have covered

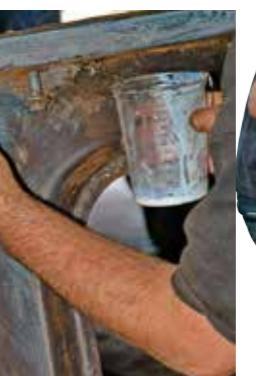
Back to basics

Welds were ground down and surface rust removed along with any traces of old coating. This stage is an essential one to ensure a strong final finish for the floorpan.

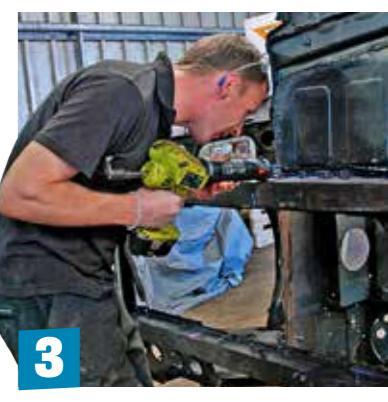
Seams sealed Seam sealer was applied to all welded seams and potential moisture traps.

neutralised. All welded seams were sealed with a flexible permanent sealer, with all of us safe in the knowledge that no rust was trapped within. Sealer was applied from a caulking gun before being brushed into every nook and cranny. Care was taken not to block any drain holes. A common point of failure with any painted coating is at outside angles and edges. Not only do these get exposed to greater abrasion, but it is also harder to get a consistently thick coating from spraying due to vortices and areas of negative pressure being formed by the pressure of the spray gun. Thus, before the final top coat was sprayed on, any edges were stripe-coated with Epoxy Mastic paint, before being quickly followed by the final top coats sprayed wet-on-wet.

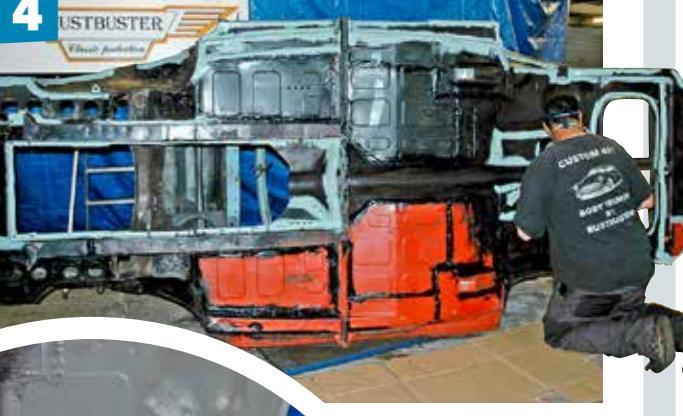
AFTER Seam sealed and painted, it's a protected for years to come.

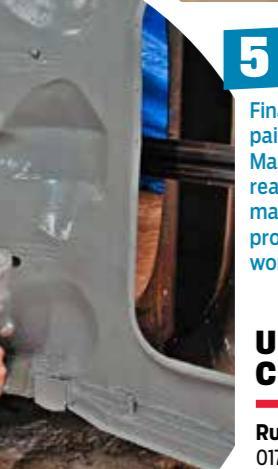
Finally, the shell was painted in 121 Epoxy Mastic topcoat, ready to provide many years of protection and worry-free motoring.
